Submersed Aquatic Vegetation Survey 2019, Upper Missouri River, Montana

AMARUQ ENVIRONMENTAL SERVICES LLC

AES-SAVS-UMOWA-2019, REVISION 0

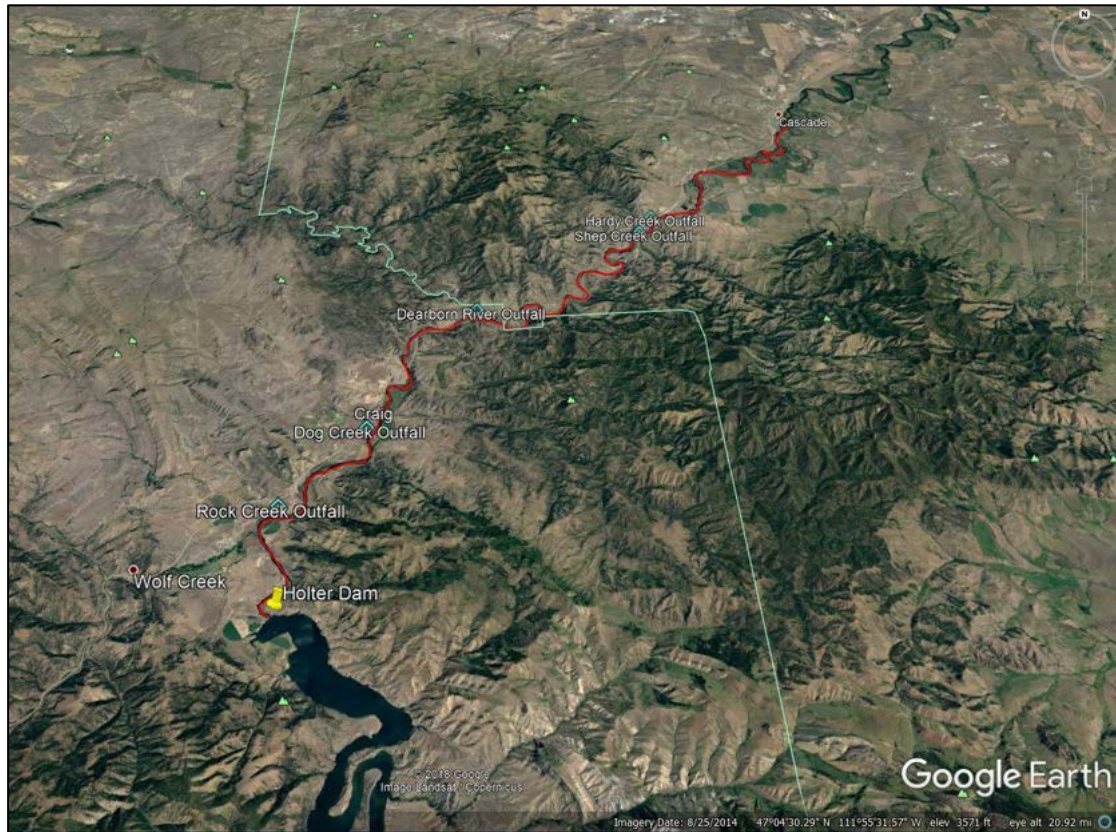
Image 1. UMOWA Study Area, 2019, showing known tributary outfalls to the Missouri River.

The 2019 study area (**Image 1**) delineation started at the foot of Holter Dam (46° 59'30.35 N 112° 0'21.04 W NAD83) near Wolf Creek, Lewis and Clark County, Montana and ran north-by-northeast approximately 55 river kilometers (40km, linear) to the Craig Fishing Access Station (FAS) in Cascade, Cascade County, Montana (47° 16'49.73 N 111° 41'23.78 W NAD83). Satellite imagery analysis was used to determine an average width at river's surface to be 135 meters and an average depth of 2.5 meters. A seasonal mean discharge of 193 cubic meters per second (m^3/s^{-1}) (**Figure 1**) was measured at the United States Geological Service (USGS) National Water Information System (NWIS) Station 06074000² in Cascade, Montana.

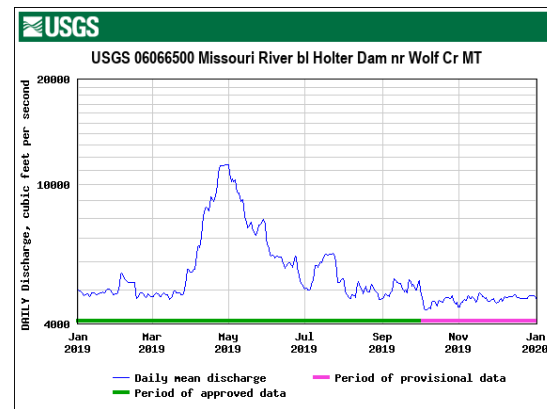
Figure 1. USGS Discharge (cfs) as measured at USGS 06066500 at Wolf Creek; 01JAN2019-01JAN2020.

NWIS Station 06066500³ at Holter Dam (**Figure 3**) is a pass-through facility managed by the Bureau of Reclamation; the discharge at Holter Dam being determined by BOR releases at Canyon Ferry Dam (USGS 0605800)⁴ in Canyon Ferry, Montana, 43.8 km upstream from Holter Dam.

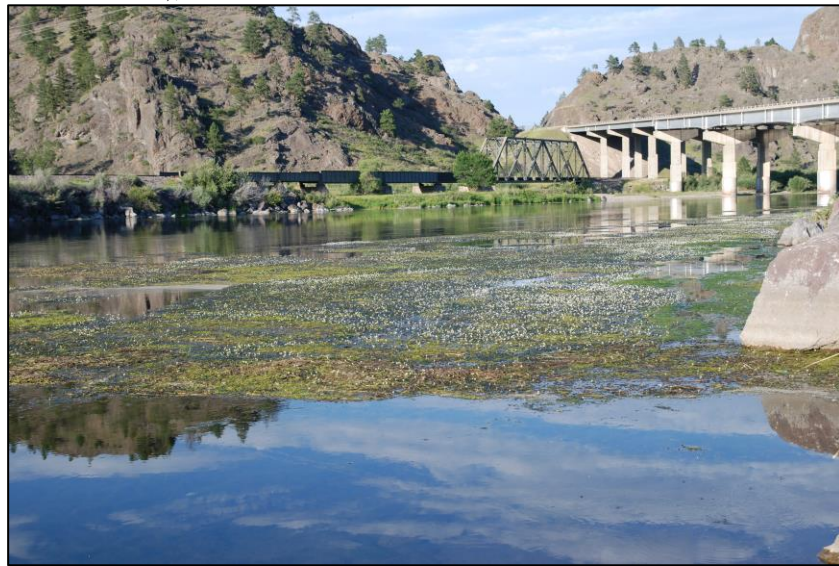
Image 3. White water buttercup infestation at Dearborn FAS (47°7'39.70"N 111°54'53.73"W), c.a. 2015. Photo Credit: Peter Rice

expansion of nuisance SAV throughout the region, and a brief inspection during the summer of 2015 found many areas above and below Craig, Montana to be completely infested with White water buttercup (**image 3**).

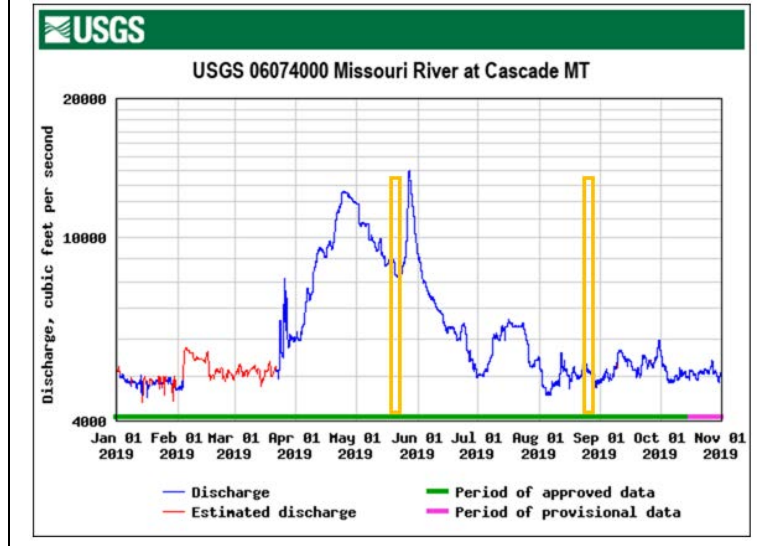
Figure 2. USGS NWIS Station 06074000 Discharge (cfs), 01JAN19 to 31OCT29. SAV assessment dates highlighted in yellow boxes.

would have greatest souring effect during the intervals between surveys, 2019. The first survey occurred 24-26MAY2019 at a recorded discharge at Holter Dam of $184 \text{ m}^3\text{s}^{-1}$ (Figure 2) and water temperatures averaged 8.4°C during the survey period (Figure 3). Individual data parameters collected and recorded in continuous intervals during the survey included depth, bottom

Despite a lack of sequential season data, broad assumptions may be inferred from current dataset: Sequential hydroacoustic surveys conducted in 2019 and following a peak flow of some ~13,500cfs (**Figure 2**) just prior to 01JUN2019 revealed very little change in river geomorphology or to sediment distribution composition (cobble: silt) in all areas surveyed. Significant differences to plant community composition and distribution were noted by river mile

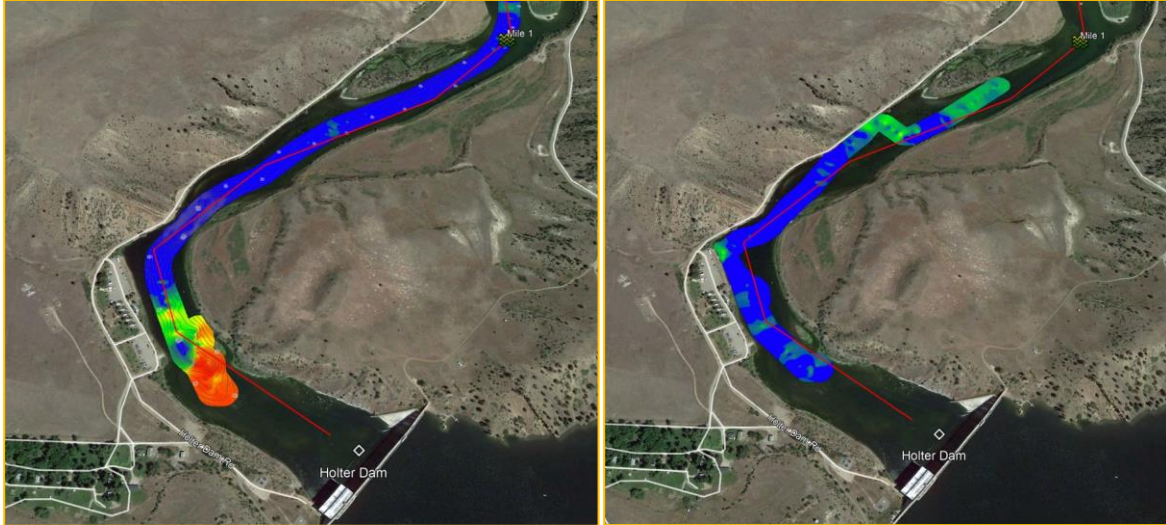
Image 4. Total (0-100%) Submersed Aquatic Vegetation Densities at Holter Dam, in May (left) and then in August (right) following seasonal peak discharge 2019. *Photo Credit: Amaruq Environmental Services*

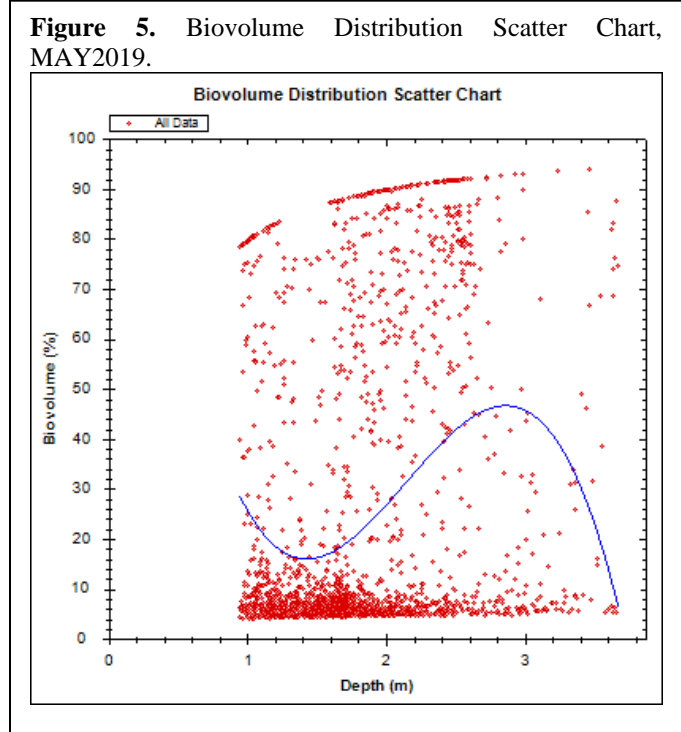
Survey data collected 24-26MAY19 detected only three species of SAV within the 55km length of the study area; Northern milfoil (*Myriophyllum sibiricum*, **section 5.1.1**), Leafy pondweed (*Potamogeton foliosus*; **section 5.1.2**), and Curlyleaf pondweed (*Potamogeton crispus*; **section 5.1.4**). During this time period, none of the SAV localities surveyed were in excess of 40% by rake-sample volume and of a total of 340 sample points, most samples returned less than 5% “full” for any species. Biovolume distribution data was parsed to remove data collected where hydroacoustic transducer height-over-ground was $\leq 0.3\text{m}$ to remove errors associated with insufficient height over biomass (**Figure 5**).

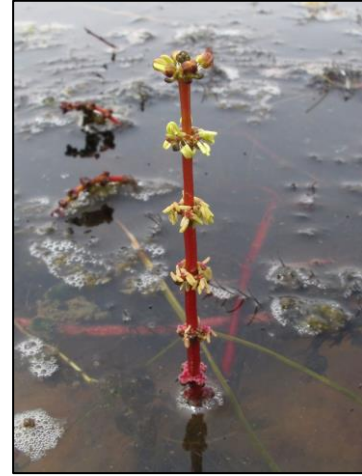
Image 9. Northern milfoil (*M. sibiricum*) inflorescence.
Photo: Vernon Smith, 2012.

M. sibiricum is a perennial that flowers twice a year, typically mid-June and late-July, followed by auto-fragmentation of the plant after each flowering. Northern milfoil typically goes dormant during the late fall; though standing vegetation may be found throughout the winter season in minimally disturbed areas. Winter mortality, while not common with this species, may occur if the seedbed lies in seasonally exposed areas, but unless the root system-hosting sediment bed is exposed to temperatures below 0°C for extended intervals of time, the root system is likely to overwinter. Regrowth begins early the following spring once water temperatures reach about 15°C (Smith and Barko 1990), though actively growing plants have been observed within the study area as late as October and as early as March (*author, personal observations*).

Like other members of the genera *Myriophyllum*, *M. sibiricum* produces turions, or reproductive vegetative structures, in order to overwinter. Seed production does occur but is minimal in contrast to the ease with which this species disperses through vegetative fragmentation and propagation. Northern milfoil has thin stems, which can be appear green, brown, or pinkish white depending on growth stage and ambient growth conditions. There are typically four feather-like, deeply-dissected leaves (**image 8**) whorled around the stems with 10 (or less) subdivided leaflets per stem, and the inconspicuous, pink to yellow four-parted flowers (**image 9**) rise 5-10 cm above the surface of the water from the terminal spike. Northern milfoil is often confused with the non-native and invasive Eurasian milfoil (*M. spicatum*); though the latter species most often has ≥ 14 leaflet pairs per leaf. It is worth noting that Northern milfoil readily hybridizes with the invasive species, Eurasian milfoil, and the resultant hybrid (Hybrid water milfoil or *M. sibiricum x spicatum*), may be indistinguishable from either parent without the use of genetic analysis.

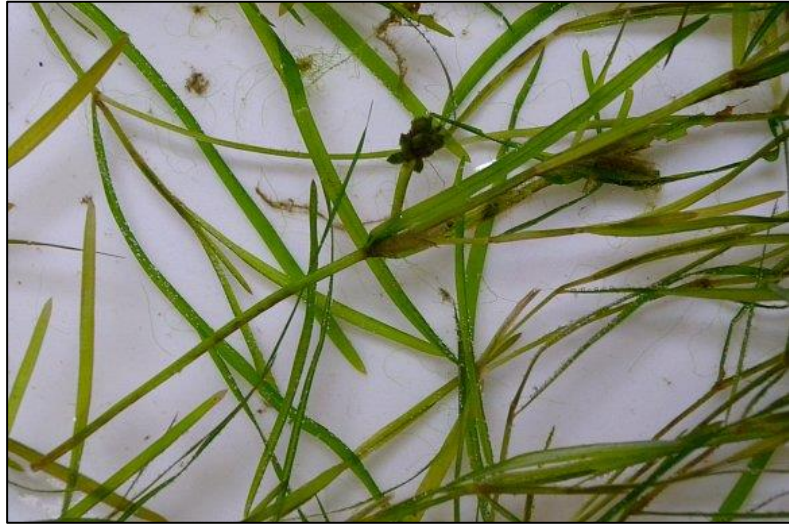
Image10. Leafy pondweed (*P. foliosus*) foliage and seed cluster.

10) Foliage often appears pale green to yellowish green, depending on seasonal conditions

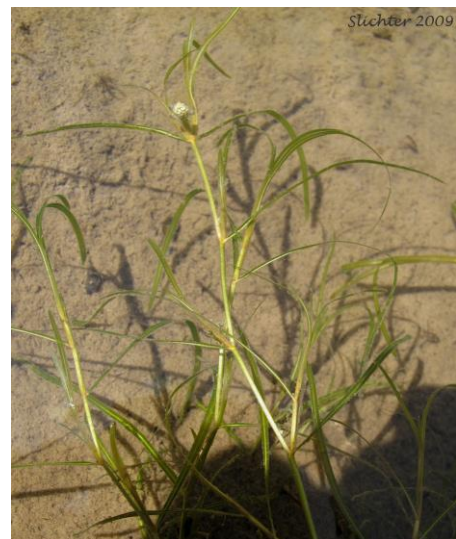
Image 11. Leafy pondweed (*P. foliosus*) inflorescence.

(**image 11**), usually in mid-to-late summer, and are

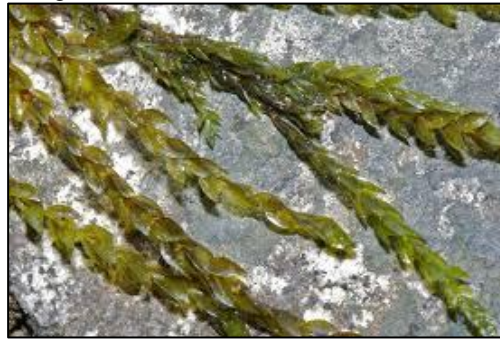
Image 12. Common watermoss (*F. antipyretic*) foliage. Photo: ©2012 calbryos group

5.1.3 Common watermoss (*Fontinalis antipyretica*); Common watermoss (*Fontinalis antipyretica* also known as Robust Fountain Moss¹². Common water moss is a dark green underwater plant that attaches to rocks or logs in flowing water, or floats loose or attached in still water and is one of only a few truly aquatic mosses (*Bryophyta* species) in the Pacific Northwest. The leaves are sharply pointed, ridged, overlapping, and arranged in 3 rows along the entire length of the stems which may grow ≥ 60 cm long. These stems appear triangular in cross section. Common water moss does not produce flowers, reproducing by stolons, plant fragments, or spores instead. It is often found dried and dormant above water in the summer. *Fontinalis*, like many members of *Bryophyta* is widespread throughout the northern hemisphere and is found in both lacustrine and riverine systems. *Fontinalis* is known to form extensive and dense monoclonal colonies, and as such, becomes an important habitat for stream invertebrates and even a protective site for fish eggs.

Common watermoss may be an indicator of clean water; however, it also occurs in highly turbid, nutrient rich waters as well. This species may be sensitive to alkaline waters, preferring a pH range of 4-5.5 and will generally not tolerate temperatures in excess of 20°C which induces dormancy in this species until temperatures return to an optimum of 10°C. This species occurs in both lacustrine and riverine systems and is well adapted to living in fast moving water conditions, such as may be found across shallow gravel bars throughout the study area.

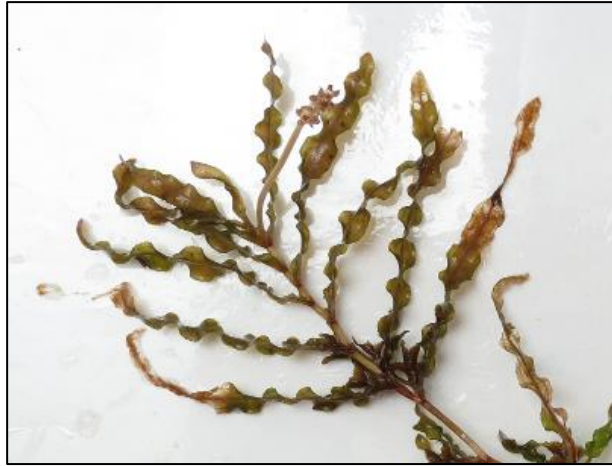
Image 13. Curlyleaf pondweed (*P. crispus*) foliage.
Photo: Paul Skawinski, *Aquatic Plants of the Upper Midwest*

Curlyleaf pondweed grows entirely as a submersed aquatic plant with no floating leaves, and plants will not live long if uncovered during periods of low water. Leaves are alternate, 4-10 cm in length and 5-10 mm wide. Leaves (**image 13**) are conspicuously toothed along leaf margins, sessile (attached directly to the stem), narrowly oblong, undulate (wavy like lasagna noodles) with a conspicuous mid-vein. Leaf tips are obtuse (rounded or blunt), olive-green to reddish-brown, and somewhat translucent. Stems are flattened, channeled, with few branches. Rhizomes are pale yellow or reddish, rooting at the nodes. Small flowers (3 mm wide), with greenish-brown or greenish-red sepals form on a terminal spike above the waterline producing 3-4 fruits per flower¹⁴.

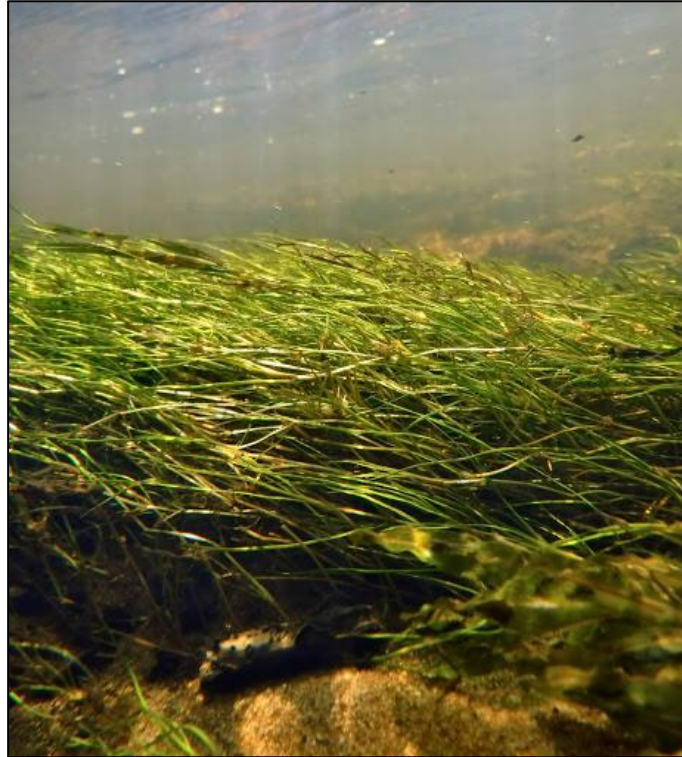
Image 16. Horned pondweed (*Zannichellia palustris*) infestation
Photo: SEINet Portal Network. 2020. <http://swbiodiversity.org/seinet/index.php>. Accessed on May 19.

pondweed is an entirely submersed aquatic perennial grass species and is native to the North American continent, including the Canadian Provinces and Alaska. Like many other aquatic weed species, Horned pondweed may be found in a wide spectrum of environments; fresh brackish and tidal wetlands, (chloride range ~185-1200 mg/l¹⁵) have all been documented as being adequate for establishment and survival. This species requires flowing water to thrive. Horned pondweed is a appears as slender, thread-like branches with opposite leaves and may approach 2 meters in length; particularly when found growing within the confines of irrigation conveyance systems (**Image 16**).

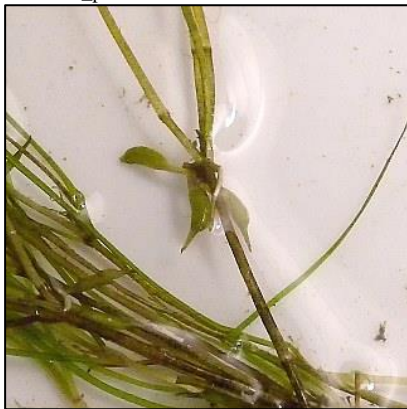
Image 17. Horned pondweed (*Zannichellia palustris*) with distinctive “horned” seeds located in leaf axils. Photo: https://www.illinoiswildflowers.info/wetland/plants/horn_pondwd.html

leaves are arranged oppositely or in pseudo-whorls at intervals along these stems; they are 0.4 to 1.1cm long and 0.5-1.0 mm. across. The leaves are light to medium green, linear in shape and flattened, smooth along their margins, and glabrous, tapering to acute tips. The stems and leaves often darken with age or become brown from a coating of algae. Membranous sheaths surround the stems at the bases of the leaves; these delicate sheaths disintegrate with age. Horned Pondweed is monoecious, producing separate male and female flowers on the same plant. These inconspicuous flowers are located at the bases of the leaves, where male

and female flowers often occur together. The root system is fibrous and rhizomatous. Dense, monoclonal stands of Horned pondweed will often develop from the rhizomes and seed dispersal seems to be a secondary dispersal method when compared to vegetative fragmentation. Horned pondweed will only tolerate partial shade underwater and as a result, is generally not found in water deeper than 1.5m. Distinctive fruits may be found in the leaf axils (**image 17**); However, these are only present as the plant achieves sexual maturity and may not be present to aid in identification. The seed structures are toothed along one edge and have a horn appearance averaging 1-2 mm long. Flowering and seed set may occur anytime and continuously thereafter from July through October.

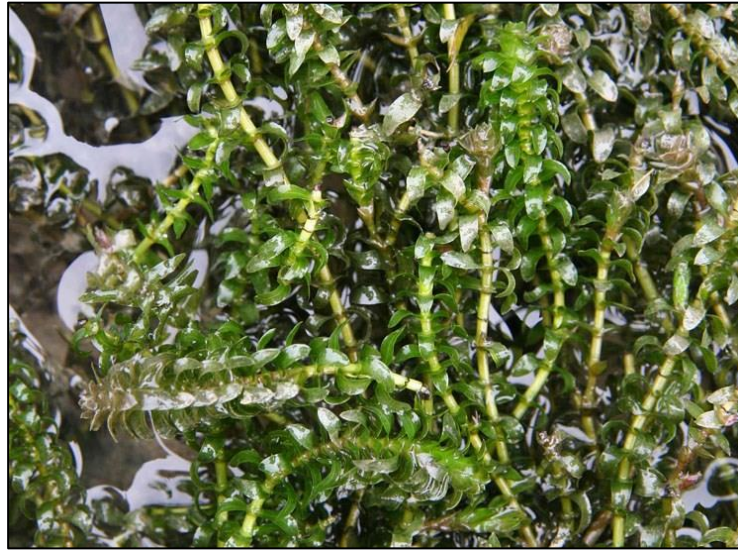
Image 19. *Elodea canadensis*, or Canadian waterweed, (*Elodea canadensis*) exhibiting typical, monoclonal growth typical of the genera. © Robert Vidéki/Doronicum Kft./Bugwood.org - CC BY-NC 3.0US

(**Image 19**) and these stems have

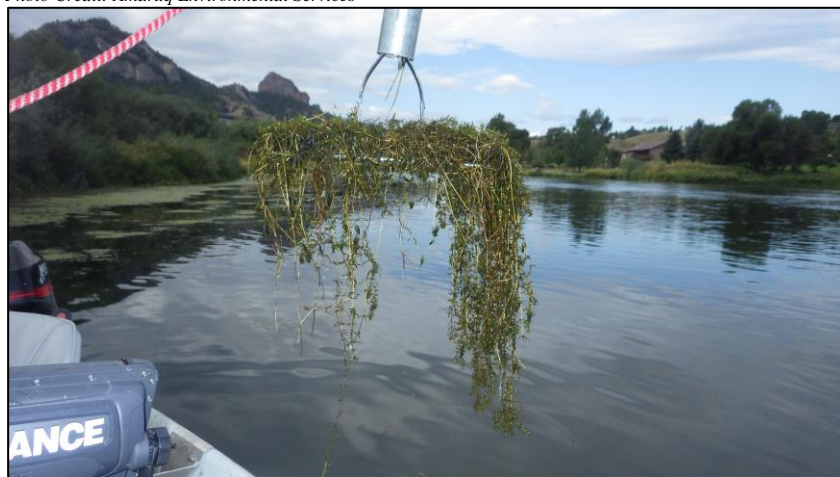
Image 20. Canadian waterweed (*Elodea canadensis*) August 2019.

(average ~45% by sample density) from the previous survey, as could be expected given time of year and average growing conditions. A large, single population of Elodea (*Elodea canadensis*; **Section 5.1.11**) was detected just upstream of the confluence with the Dearborn River (**image 14**) and was not detected anywhere else within the study area in 2019. A total of 340 sample points were surveyed and, as was done for the Spring 2019 survey, biovolume distribution data was parsed to remove data collected where hydroacoustic transducer height-over-ground was $\leq 0.3\text{m}$ to remove errors associated with insufficient height over biomass (**Figure 6**). As was noted during the spring 2019 survey, large, dense stands of Common watermoss (100%) occurred throughout the study area, though it is interesting to note that those located during 23-25MAY19 (**image 5**) were no longer present at the foot of Holter Dam (**image 18**); possibly a result of scouring action following peak release on or before 01JUNE19.

serrated but not toothed (**image 20**). The roots are white and threadlike. This species is
